Appendix B
Constraints of Habitat and Channel Stability
on the Development of Drainage Improvement Alternatives
for the S-1, S-2, and S-3 Urban Planning Zones
and the N-1, N-2, N-3, N-4, and N-5 Urban Planning Zones

**CONSTRAINTS OF HABITAT AND
CHANNEL STABILITY ON THE DEVELOPMENT OF
DRAINAGE IMPROVEMENT ALTERNATIVES FOR THE
S-1 TO S-3 AND N-1 TO N-5 URBAN PLANNING ZONES**

Prepared by:
Wright Water Engineers, Inc.
2490 W. 26th Ave., Suite 100A
Denver, Colorado 80211
And Edwin Herricks, Ph.D.

January 2001

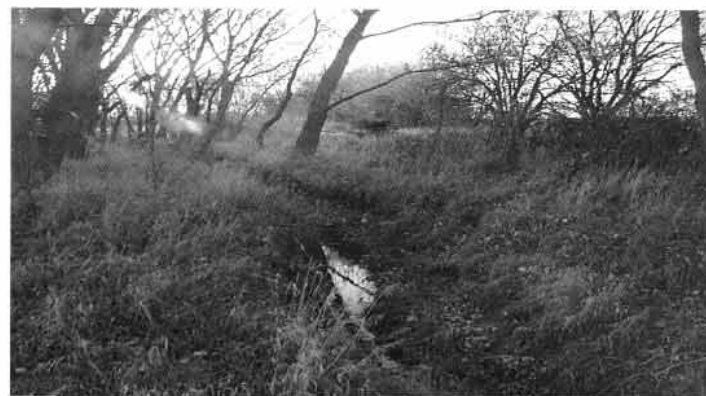
Photograph 1. Stream channel immediately downstream of 40th Street in the S-2 catchment. A riparian buffer has been preserved.

Catchment S-2 consists mostly of agricultural development except for the golf course on the northern edge of the catchment. The riparian area around the channels has been preserved in some areas. This includes native trees and shrubs within a buffer zone around the drainageway. Photograph 1 shows the area immediately downstream of 40th Avenue. In other areas, grading for agricultural development has taken place up to the edge of the low-flow channel of the drainageway. There is no riparian vegetation in these areas. Photograph 2 shows the area immediately upstream of 40th Avenue.
